NONDESTRUCTIVE EVALUATION AT MISSION SAN MIGUEL – ACHIEVEMENTS AND LIMITATIONS

Douglas W. Porter (1), Ronald W. Anthony (2)

KEYWORDS: Nondestructive evaluation, resistance drilling, micro-drilling, digital radioscopy, x-ray, termites, decay

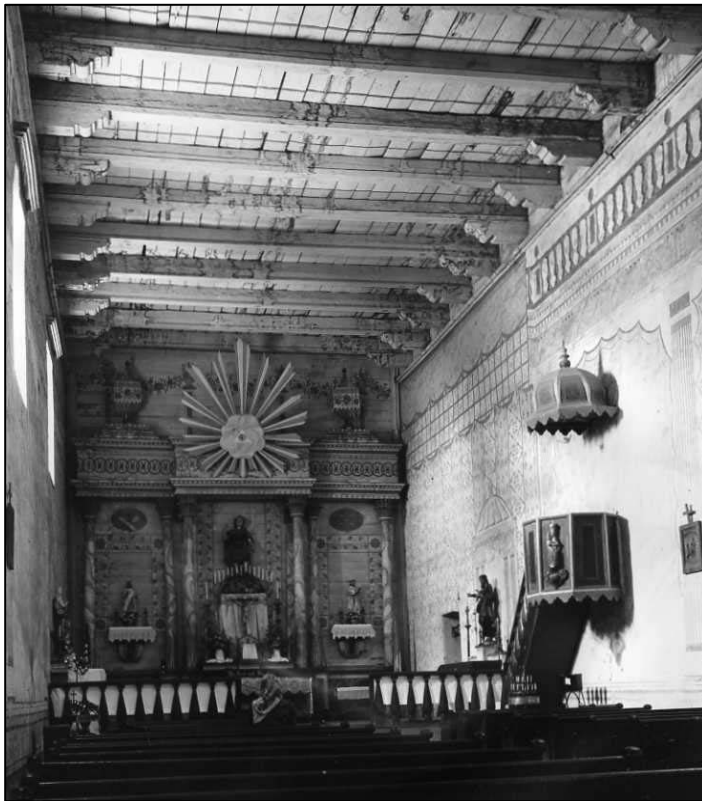
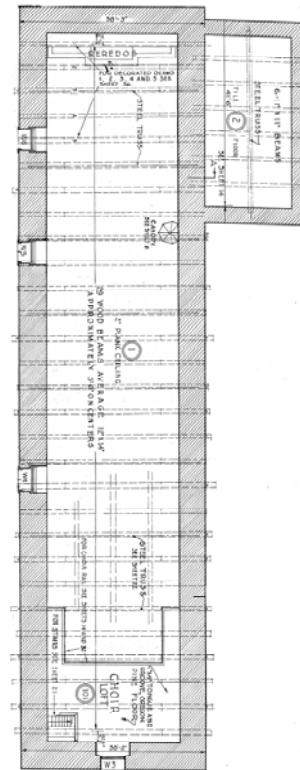
Figure 1

The church retains an exceptional level of early fabric, including a decorative paint scheme on wood and plaster completed in 1822. In this early-20th century photo, extensive deterioration of the painted ceiling is apparent.

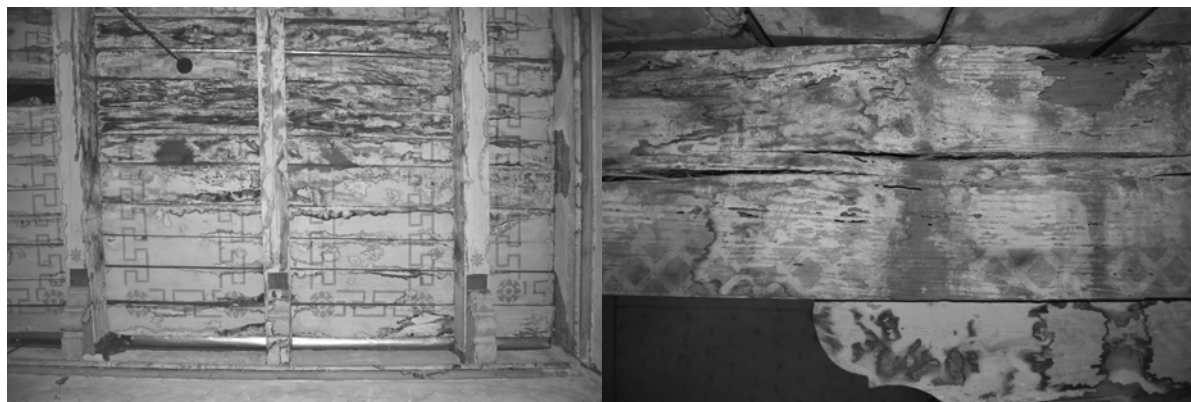
Figure 2

Several vigas were displaced in the last earthquake, particularly in the sacristy where paint ghosts on vigas and corbels indicate total displacement of 15 cm or more. Displacements are undoubtedly cumulative, as the result of several earthquakes, and evidence of earlier viga movement can be seen in photographs taken before 2003 [4]. The source of most of the movement seems to have been the north sacristy wall, which was recently stabilized by the installation of temporary walers against the wall exterior. Displacements in the nave are more modest, totaling no more than 2 to 5 cm. Embedment depths of vigas and cantilevered beams in the choir and sacristy are currently unknown. Sacristy vigas are of particular concern because of the amount of displacement at the south sacristy wall, and the unknown condition of the wood remaining in the wall (Figure 2).

Insect damage has been most severe in ceiling construction, with lesser levels of damage in the retablo and pulpit. Inspection of the building produced evidence of infestations by drywood and subterranean termites, and probably at least one species of wood-boring beetle. Of these, the damage caused by drywood termites is by far the most extensive, with damage from this insect appearing in virtually every ceiling element examined. In the nave, where deck boards could be examined from the attic space, damage visible on the upper surfaces of planks was extensive, affecting perhaps 30 percent of the total deck area. Heavy timber decking elements included in nave and sacristy ceiling decks are noticeably more severely damaged than much of the thinner deck material. Vigas, corbels, and the torus-molded timber installed in adobe coursing exhibit many of the same conditions. Visual inspection of the exposed ends of sacristy vigas and corbels on the exterior north wall discovered severe deterioration within several inches of the exposed surfaces.

Damage associated with water staining ranges from partial pigment loss to disfiguring dark crusts. Bare wood at corbel ends (left photo) indicates displacement of several cm in sacristy vigas. Nearly all of the wooden ceiling elements have been damaged by drywood termites (right photo), some severely.

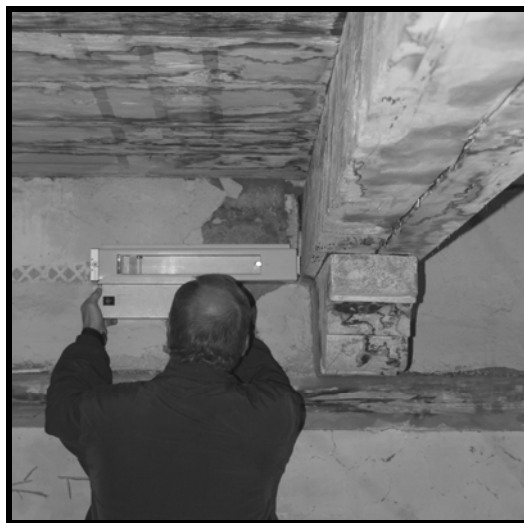
Figure 3

selected to give an indication of the typical pattern of internal damage. It was discovered that, with the larger-dimension elements like vigas, corbels, and deck timbers, the distribution of water staining is not a reliable indicator of termite damage on the interior of the elements. Resistance drilling of vigas encountered section losses, occasionally in excess of 50 percent, though damage levels were typically much lower than this; section losses were encountered in water stained elements and in elements relatively free of surface damage. In general, damage was found to be concentrated along adobe walls.

Resistance drilling of a viga to quantify internal damage due to insect attack

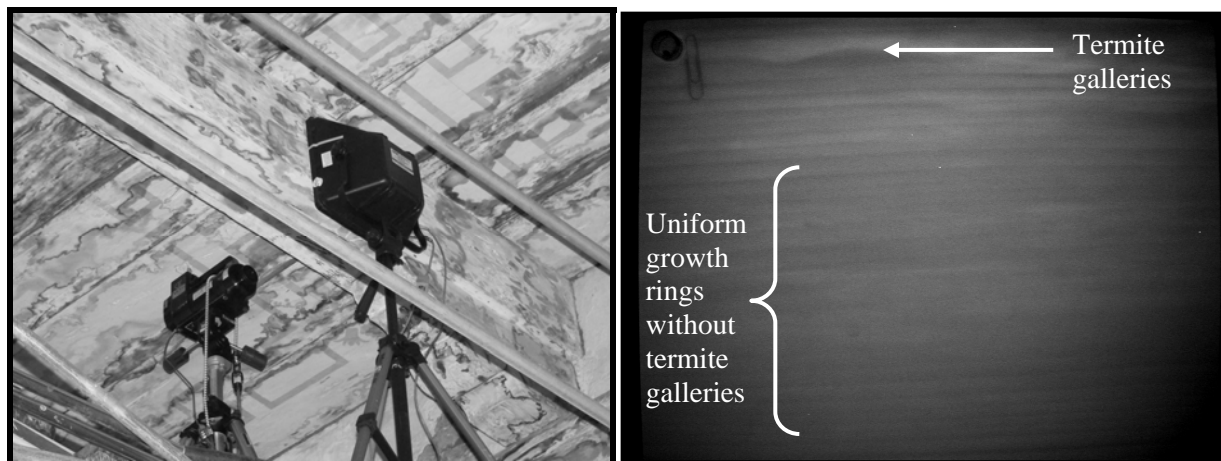
Figure 4

Digital radioscopy was used to characterize insect damage in two large dimension elements. In the first instance, the radioscopy equipment was positioned with the x-ray generating source on one side of a viga and the imager placed flush against the other face (Figure 4). At this location the viga was found to be in good condition with only a few termite galleries visible near the upper section of the viga; the lightest areas of the radiograph correspond to less wood in the cross section due to the presence of the termite galleries. In this radiograph, the grain structure of the element is fairly clear and distinct (Figure 4). By comparison, the radiograph of a severely deteriorated timber decking element is characterized by amorphous grain structure and the lack of any discernible galleries. This is because the three-dimensional piece of wood, riddled with termite galleries, is reduced to a two-dimensional image on the radiograph so the galleries at the “front” of the piece overlap with those in the “center” and the “back” of the piece. Although radioscopy could be used to determine the presence of, and quantify, termite damage, the technique is more cumbersome and time-consuming than resistance drilling for a more comprehensive investigation.

Digital radioscopy setup on viga 34 in the sacristy (left photo) and radiograph of viga 34 showing the top half of the viga, approximately 79 inches from north wall (right figure). Note the termite galleries near the upper surface of the viga.

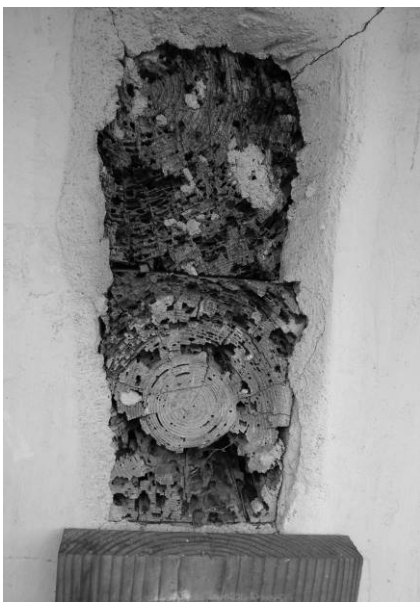
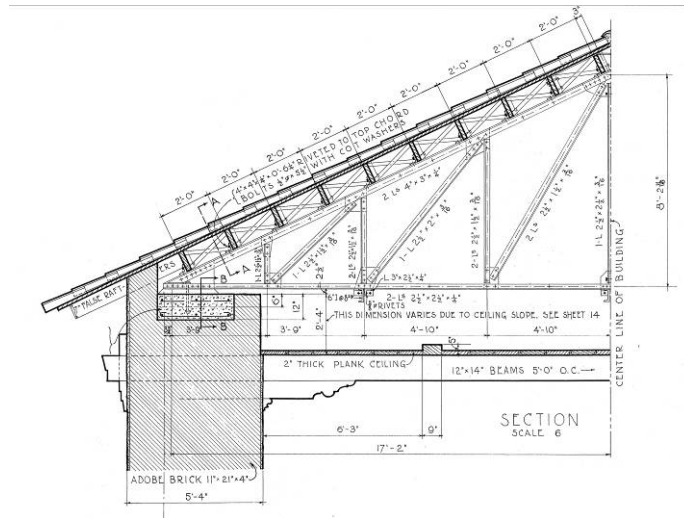
Figure 5

Many viga and corbel ends exposed on the building exterior are riddled with termite damage (left). Quantifying the surviving section of structural wood embedded in adobe walls will require a combination of resistance drilling at an angle and direct inspection with a videoscope.

Where the elements are exposed on the interior of the building, the resistance drill will work very well for quantifying remaining section. However, it was determined in the initial survey that termite damage is concentrated along the walls, with very significant damage visible on viga and corbel ends exposed on the exterior of the building (Figure 5). Furthermore, the 2003 earthquake resulted in displacement of many of the structural wood components; in some cases, the measured lateral displacement of the vigas was in excess of 13 cm. Without knowing either the embedment depth or the condition of the viga within the wall, the effect of this level of displacement (withdrawal from the wall) on the structural integrity of the church cannot be fully assessed. Because of the thickness of the walls and the necessity of working at oblique angles to the embedded portions of the vigas, digital radioscopy has no application in this instance, and the resistance drill will have limited utility

- **Examination of embedded wood components using visual inspection, resistance drilling at an angle, and examination with a videoscope:** Examination of embedded wood will include an evaluation of damage to exposed viga and corbel ends. The resistance drill will be useful for drilling into vigas embedded into the adobe walls at approximately a 45° angle to the wall surface (resulting in effective examination depths of 20 cm). Where deterioration is found, it may be necessary to collect additional data using a videoscope or fiber-optic camera. This will require boring holes in wooden elements to create a path for the scope. Repair thresholds determined as part of the engineering evaluation will help to limit the extent of this destructive investigation; once sufficient sound wood has been discovered in a particular location, additional investigation becomes unnecessary.
