NONDESTRUCTIVE EVALUATION AT MISSION SAN MIGUEL – ACHIEVEMENTS AND LIMITATIONS

Douglas W. Porter (1), Ronald W. Anthony (2)

(2) Anthony & Associates, Inc., USA

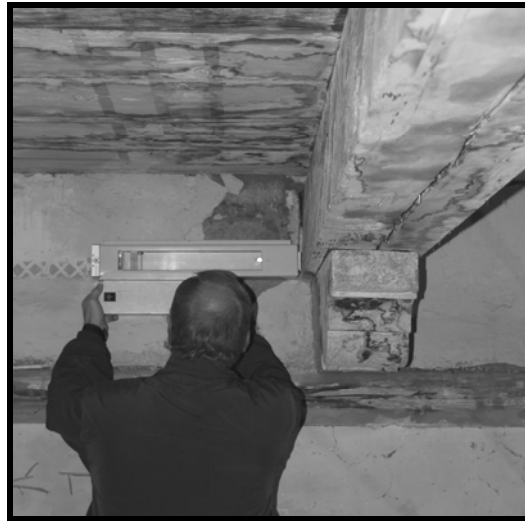
Figure 3

selected to give an indication of the typical pattern of internal damage. It was discovered that, with the larger-dimension elements like vigas, corbels, and deck timbers, the distribution of water staining is not a reliable indicator of termite damage on the interior of the elements. Resistance drilling of vigas encountered section losses, occasionally in excess of 50 percent, though damage levels were typically much lower than this; section losses were encountered in water stained elements and in elements relatively free of surface damage. In general, damage was found to be concentrated along adobe walls.

Resistance drilling of a viga to quantify internal damage due to insect attack

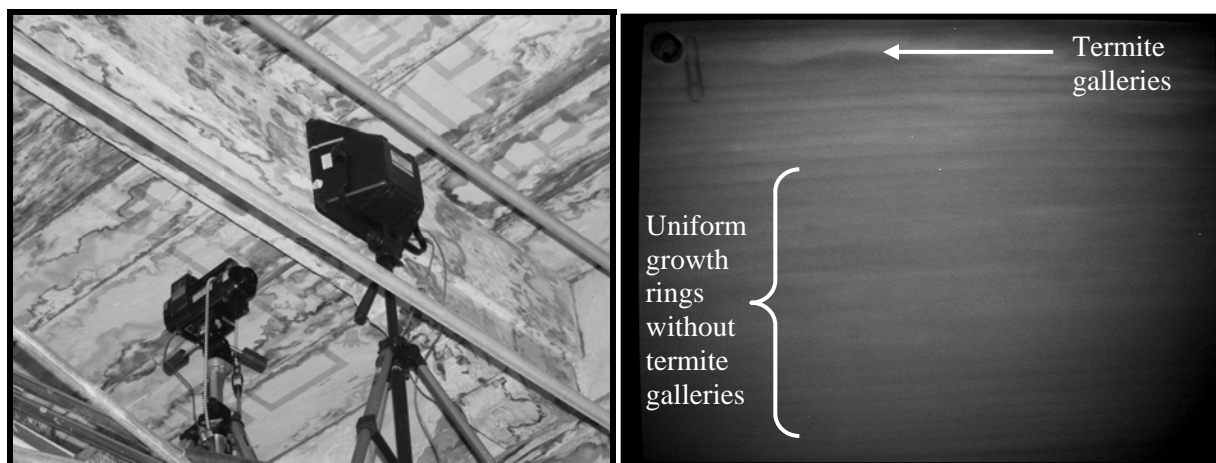
Figure 4

Digital radioscopy was used to characterize insect damage in two large dimension elements. In the first instance, the radioscopy equipment was positioned with the x-ray generating source on one side of a viga and the imager placed flush against the other face (Figure 4). At this location the viga was found to be in good condition with only a few termite galleries visible near the upper section of the viga; the lightest areas of the radiograph correspond to less wood in the cross section due to the presence of the termite galleries. In this radiograph, the grain structure of the element is fairly clear and distinct (Figure 4). By comparison, the radiograph of a severely deteriorated timber decking element is characterized by amorphous grain structure and the lack of any discernible galleries. This is because the three-dimensional piece of wood, riddled with termite galleries, is reduced to a two-dimensional image on the radiograph so the galleries at the “front” of the piece overlap with those in the “center” and the “back” of the piece. Although radioscopy could be used to determine the presence of, and quantify, termite damage, the technique is more cumbersome and time-consuming than resistance drilling for a more comprehensive investigation.

Digital radioscopy setup on viga 34 in the sacristy (left photo) and radiograph of viga 34 showing the top half of the viga, approximately 79 inches from north wall (right figure). Note the termite galleries near the upper surface of the viga.
