## **Assessment and Analysis of the Breeding Barn at Shelburne Farms**

David C. Fischetti<sup>1</sup>, Douglas W. Porter<sup>2</sup>, Ronald W. Anthony<sup>3</sup>

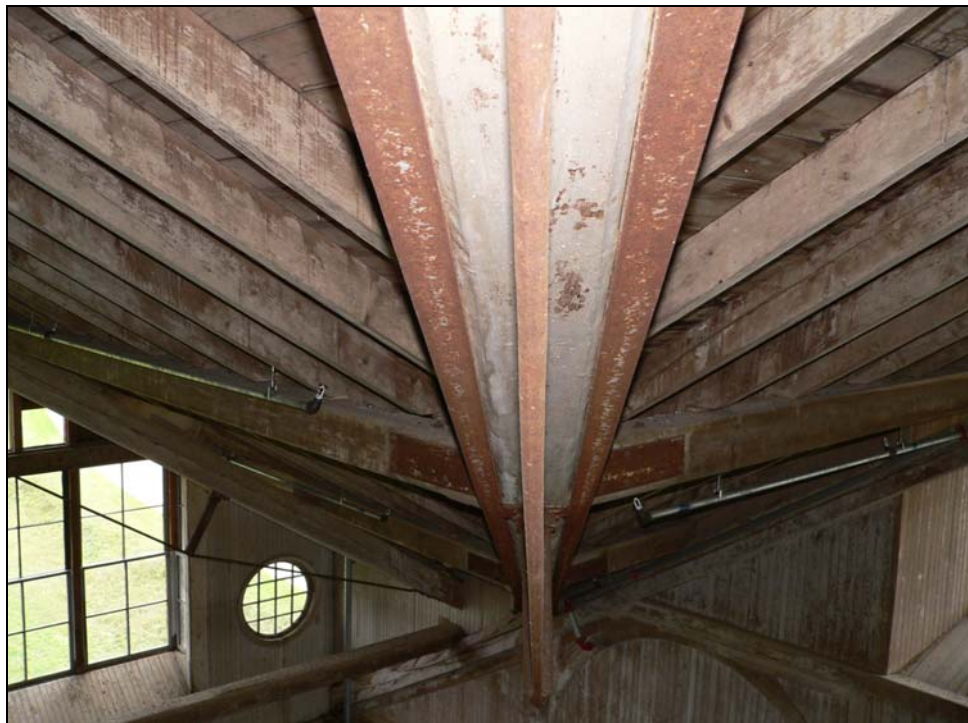
The timbers that make up the valley rafters were found to be generally in good to excellent condition. There were some exceptions. Each of the rafters was subjected to resistance drilling along its length to generate a schematic of the location and approximate extent of deterioration. Some of the rafters have deterioration on the upper face of the timber that penetrates to various depths, a condition called channelizing. Two of the valley rafters have severe deterioration of the heel where they bear on the interior wall.

*Figure 5. Valley Rafter 17 South viewed from the apex.*

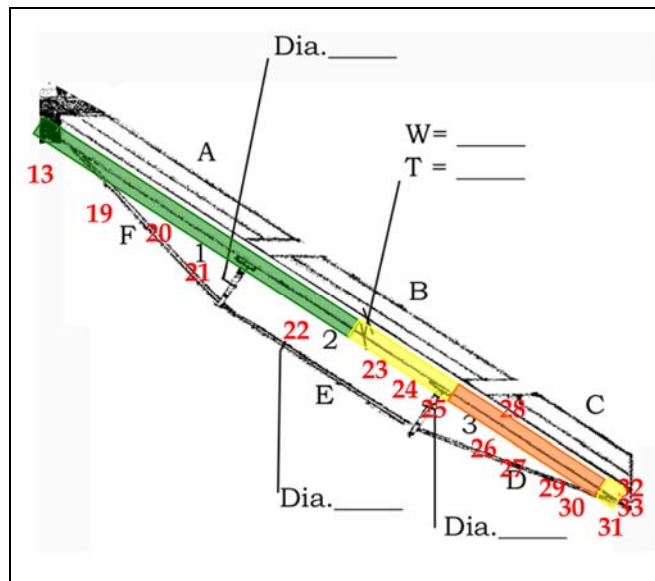
An example of one of the valley rafters is shown in Figure 5 and the corresponding resistance drilling findings are shown in Figure 6. Approximate resistance drilling test locations are marked by the drilling number on the schematic. As shown in Figure 6, this rafter has a varying extent of channelizing along the lower length of the rafter. Resistance drilling and probing revealed minor channelizing between the queen posts that progressively increased to the heel of the rafter. The upper length of the timber was found to be in good condition and is indicated as such by the green color.

**Figure 6.** Resistance drilling results for Valley Rafter 17 South.  
Numbers in red indicate drilling locations.

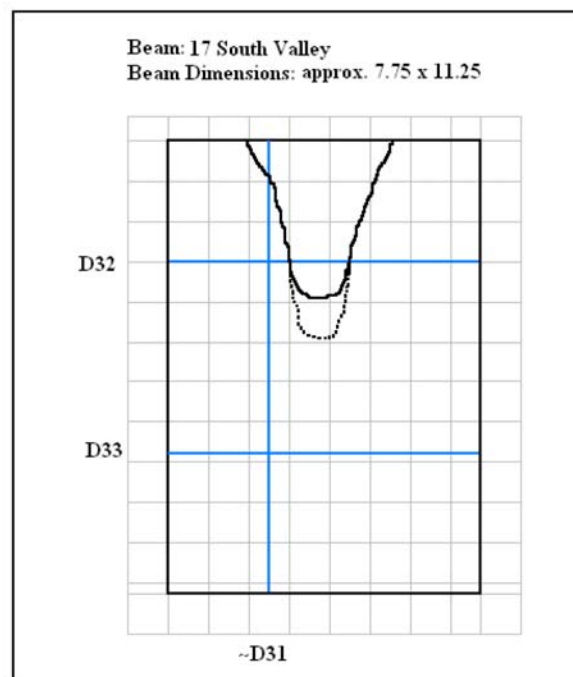
Figure 7 is a diagram of the drilling results from drillings 31, 32, and 33 (which are shown on the schematic in Figure 6). The diagram is an approximation of the width and depth of the channel due to decay as indicated by the three drillings. A decay pocket of this depth was referred to as deep channelization.

**Figure 7.** Diagram showing channelization pattern in Valley Rafter 17 South.  
Dotted line indicates likely pattern of the decay pocket, since only three drillings were conducted.

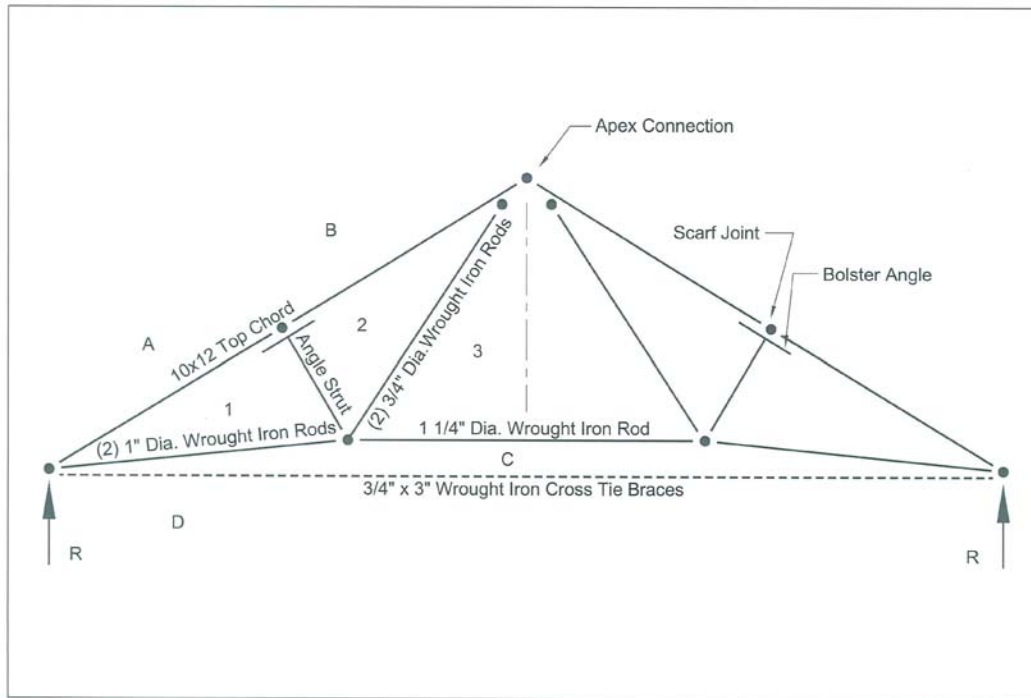
**Figure 8.** This image shows the location of the bolster angels and the connection arrangement at the apex.

Apparently, the truss in the riding ring evolved from a simple truss analyzed by graphical means, to one with purlins located between joints (Figure 10), to a system combining a truss with a horizontal tie (Figure 11). The wrought iron angles used to bolster the spliced top chord is an interesting detail. These may have been added as an afterthought, sometime during design, to reinforce the top chord acting as a two-span beam supporting purlins at the midpoint of both spans. Although it certainly was possible to obtain southern pine in twelve-meter lengths to produce a two-span continuous top chord, the designers chose to

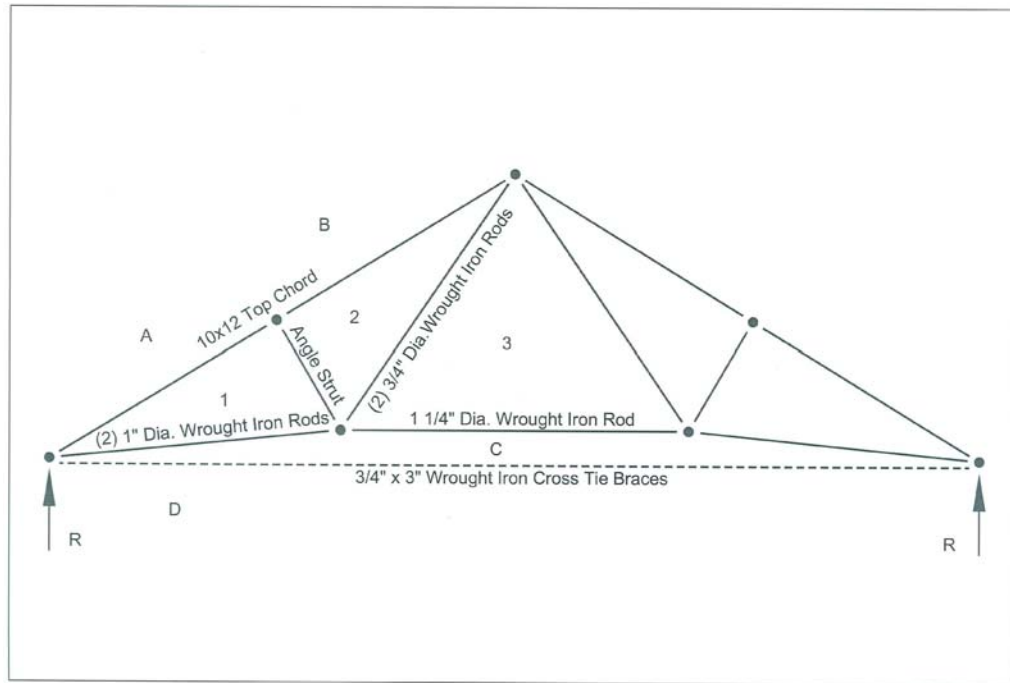
**Figure 11.** Analysis of the truss with the cross braces included, causes member C3 to revert to compression.

The addition of 1.91cm thick by 7.62cm high cross-brace tie rods to the building, apparently during construction, provides another path for the tensile force to be resisted. By including the tie rods in the analysis of the building cross section, the center tie bar of the truss becomes a zero force member (Figure 11). Analysis of the roof truss by the computer using the appropriate section properties and material stiffness shows that immediate horizontal deflection under dead load only would have been a total of five centimeters. This deflection of the trusses would have manifested itself in bending of the 25.4cm x 25.4cm post from a point at the horizontal chord of the roof trussed above the side aisle to the 20.32cm x 25.4cm girt (sill) at the heel of the truss, a distance of almost two and a half meters. Certainly, a horizontal movement of two and a half centimeters would have been observed in the post for a distance of only two and a half meters in height. If the annex had already been built or partially framed, it would have provided some restraint, pushing most of the deflection towards the posts along the north side of the building which certainly would have been observed by workmen.

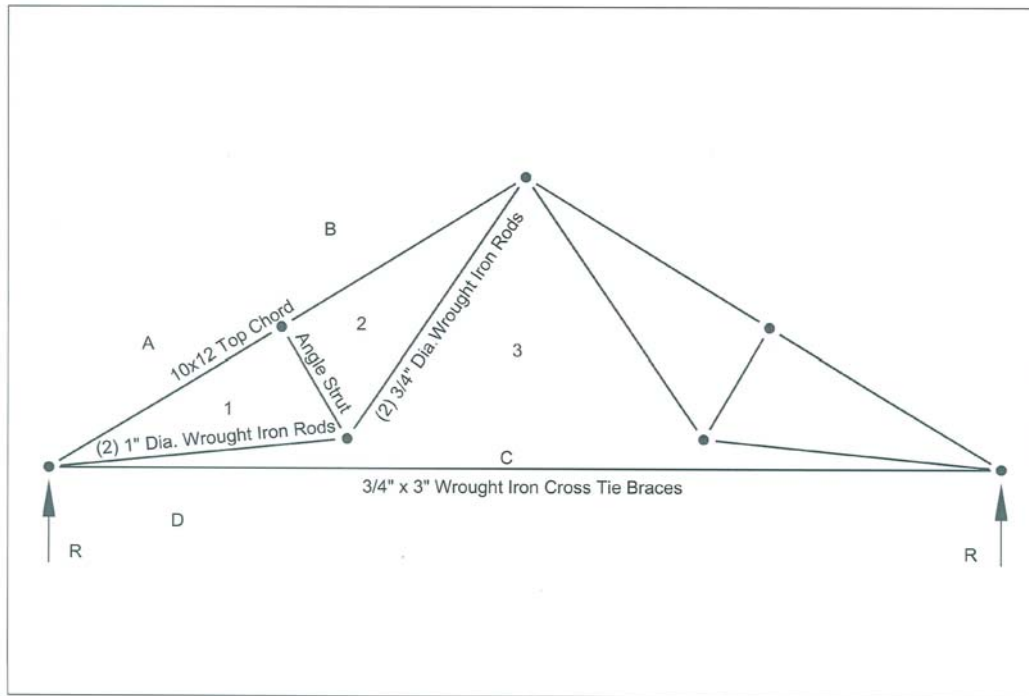
**Figure 12.** Testing and analysis indicates that the roof system acts as an A-frame with trussed rafters.

The answer was to provide additional ties to limit the movement which is natural to a truss with a raised bottom chord. In providing these ties R. H. Robertson transformed the building cross section into a tied A-frame with trussed rafters (Figure 12).
