# Carriage house stabilization at the Las Flores Adobe site: field school training in the conservation of historic adobe structures

J.M. Barrow

D.W. Porter

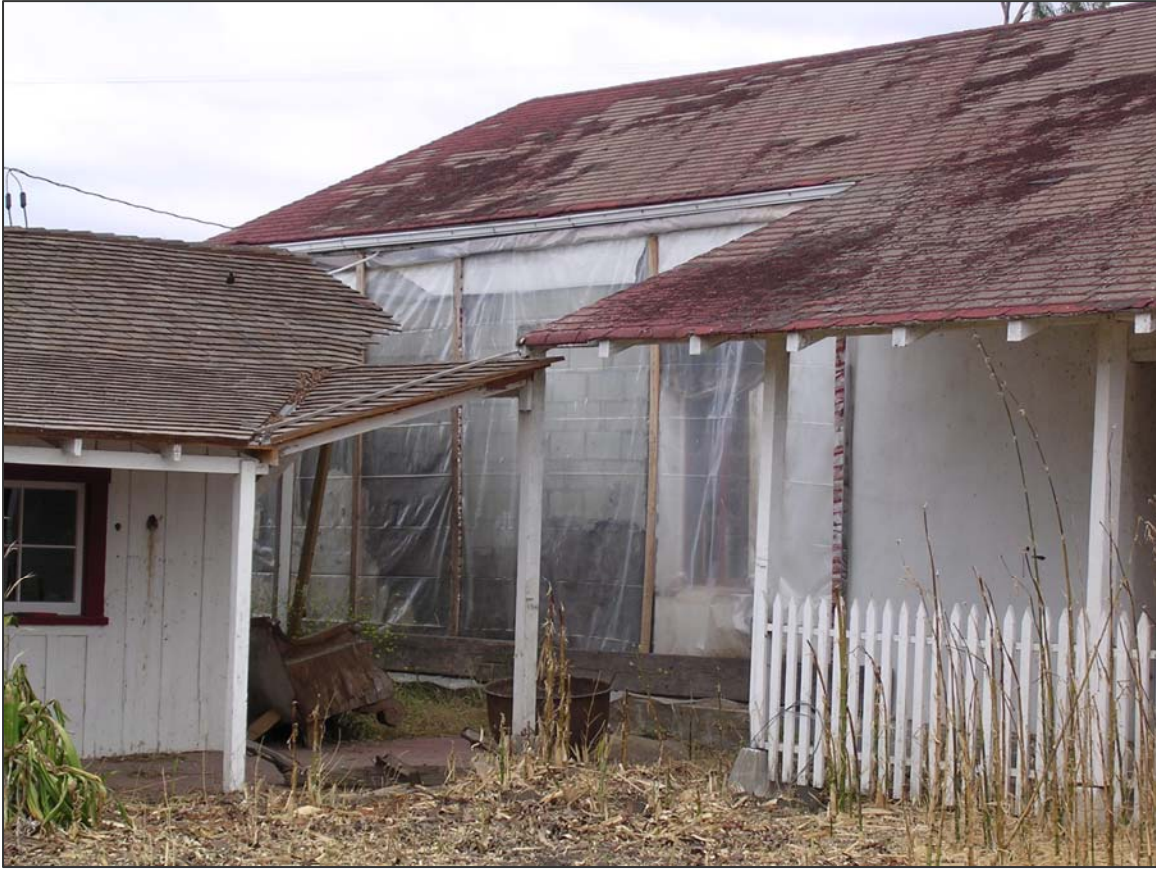
Prior to the 2004 repair project, the carriage house required replacement of an asphalt roof covering, repair of concrete infills in the south wall (visible near the center of the photo), reinstatement of a connection between Hacienda block and carriage house, installation of a seismic retrofit system, repair of decayed woodwork, and conservation and repair of earthen and lime plasters and finishes.

- The roof framing and substructure were in good condition except for a few rotted rafter ends on the south side of the carriage house portal;
- While the adobe wall materials appeared to be dry, several areas of the adobe were in very poor condition. During initial sampling, the crew encountered several voids, and in some areas hard cement infills were discovered behind the plaster. As part of a 1974 repair campaign, a large void along the south wall was infilled with concrete and concrete block. Vertical cracks in the southeast corner suggested settlement in the area;

- Cement plaster on interior and exterior walls was in generally good condition (except where cracks had occurred in the southeast corner and where plaster had been removed along the south wall to expose the concrete repair).

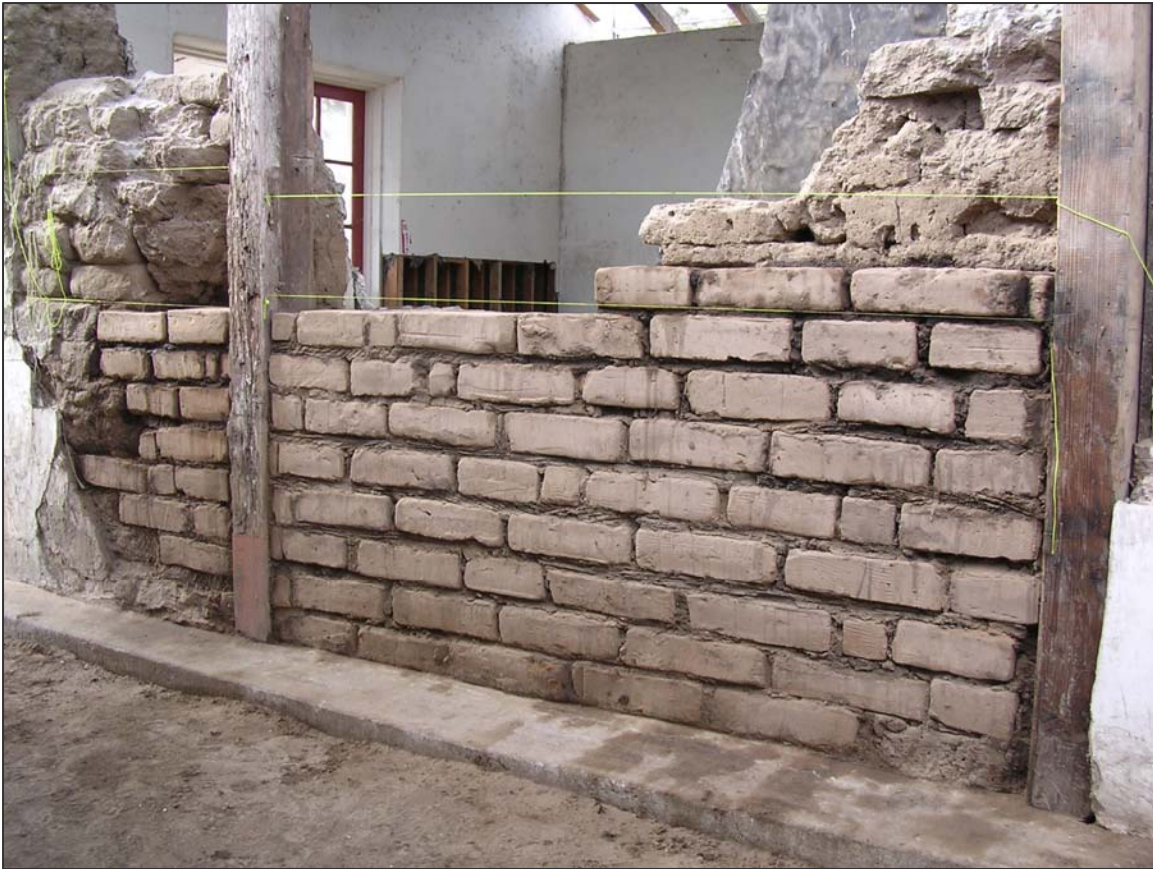
Adobe conditions were poorest on the south wall, in the vicinity of a large concrete infill. Here, exposure to weather as a result of removal of the historic connection between the buildings coupled with the addition of the *contra pared* had resulted in basal erosion of the adobe. Minimal connection between the two wythes of the adobe wall had been disrupted by erosion and several repair campaigns. In order to restore structural integrity and material continuity, the large concrete infill was removed. Disgregated and crumbling adobe was removed, though the team was able to preserve most of the historic materials, including much of the adobe wall located below the infill and subjected to the greatest deterioration. The concrete infill was replaced with adobe. The new infill was carefully “laced” into historic materials and header courses were installed to prevent separation of the two wythes that make up the 20-inch thick walls. Adobe infill materials were covered with earthen or lime plaster (depending on weather exposure) and then limewashed. In the process, it was possible to conserve some of the historic plaster and limewash finishes.

After removing concrete infills, the crew made repairs using adobe bricks. New adobes were carefully “laced” into existing work for maximum wall stability.
