# Evolving methodology in seismic retrofit: stabilizing the Las Flores Adobe

J.M. Barrow, D. Porter, S.J. Farneth, E.L. Tolles

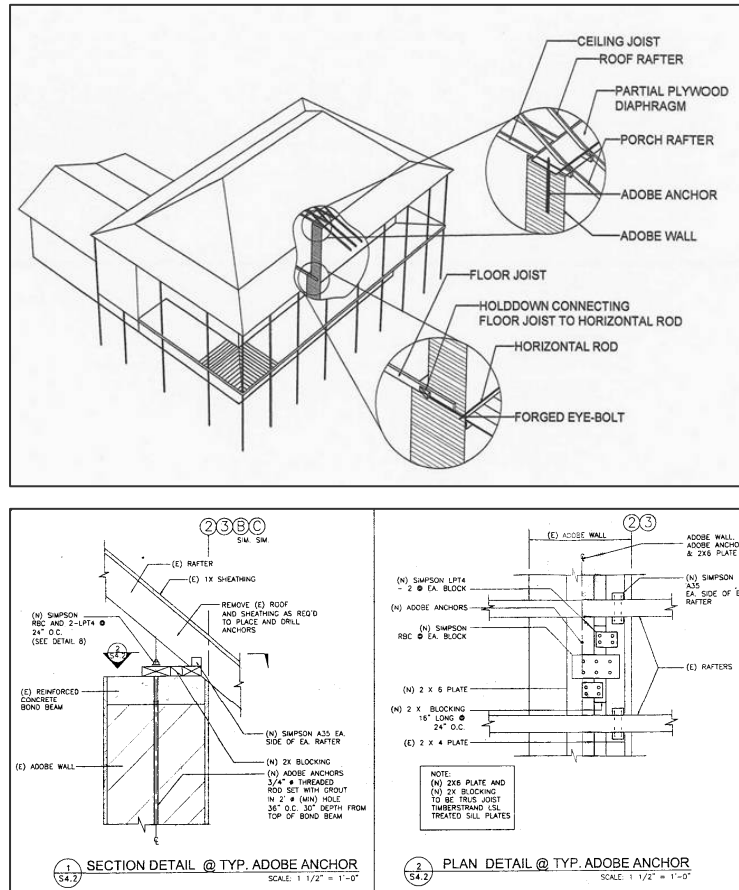
**Figure 3**

Retrofit design was focused on providing lateral restraint at the tops of walls and at the level of the second-floor frame in the Monterey block.

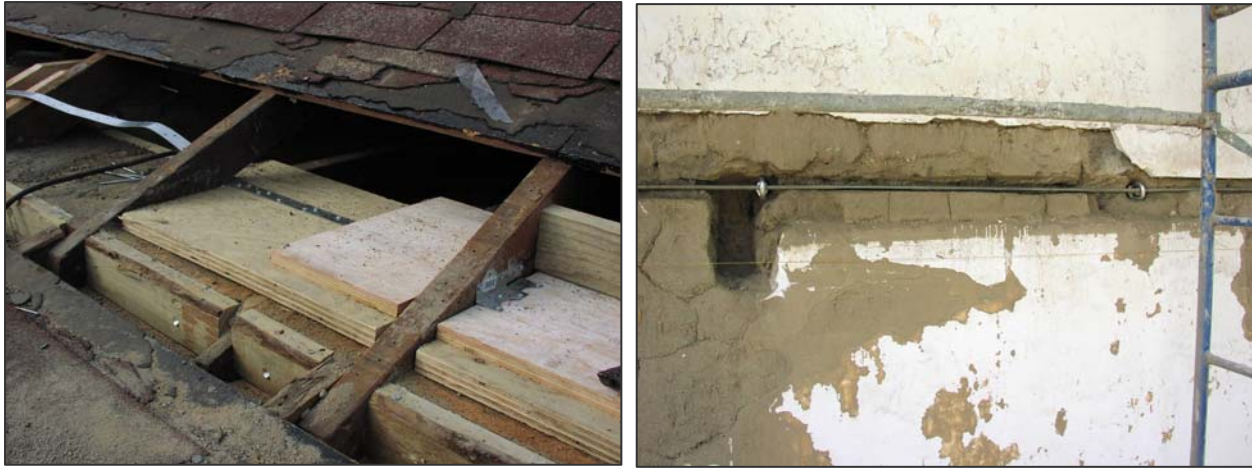
**Figure 4**

The tops of the walls were leveled by adding a pise course. The wooden bond beam incorporated a stainless steel strap and was fastened to the walls using center core pins and to the roof frame using commercially-available metal clips (left). At the level of the second-floor frame of the Monterey block, a stainless steel belt was installed below exterior plaster and tied back to floor joists using eyebolts and Simpson anchor brackets (right).

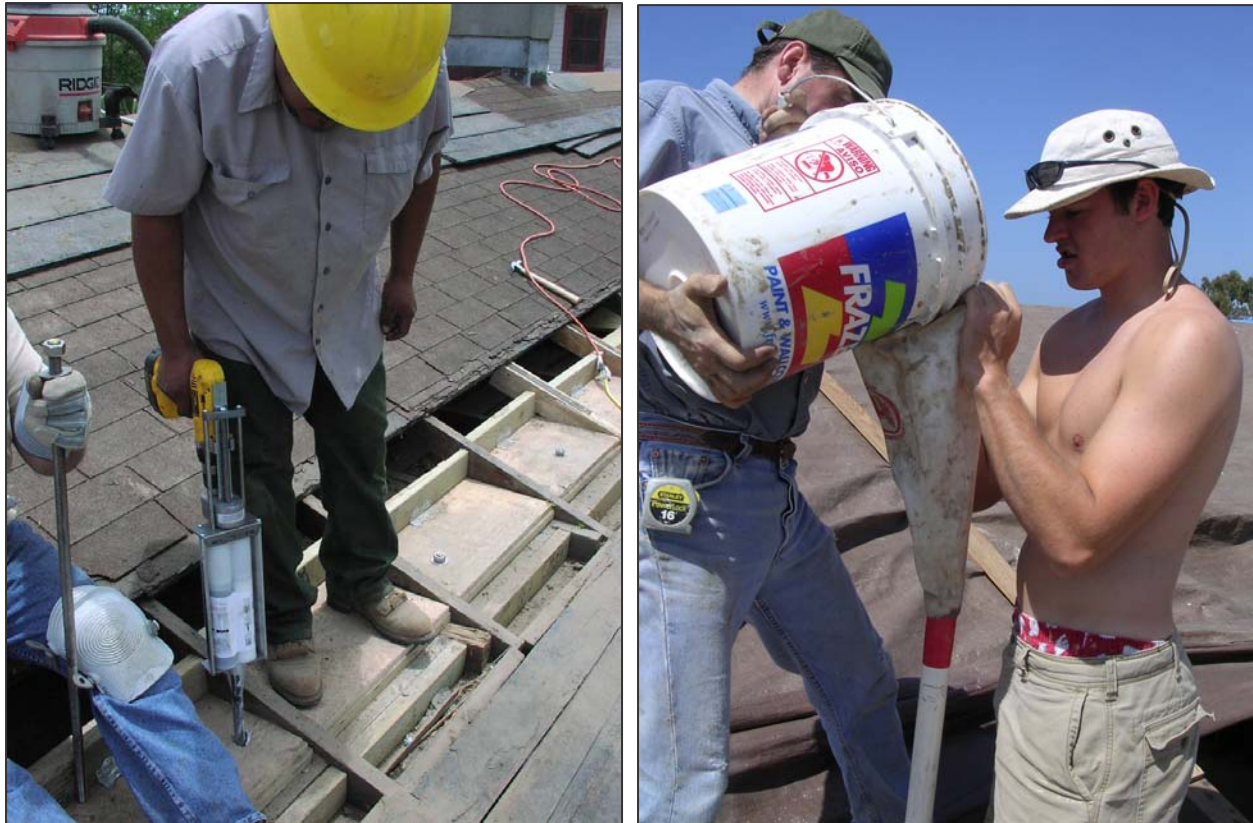
**Figure 5**

The crew used a resin-based grout for installing center core pins in the ranch house retrofit (left). For the carriage house retrofit, techniques were developed for installing an earthen grout (right). The earthen grout is more compatible with the historic wall materials and provides greater possibilities for reversibility of the treatment.

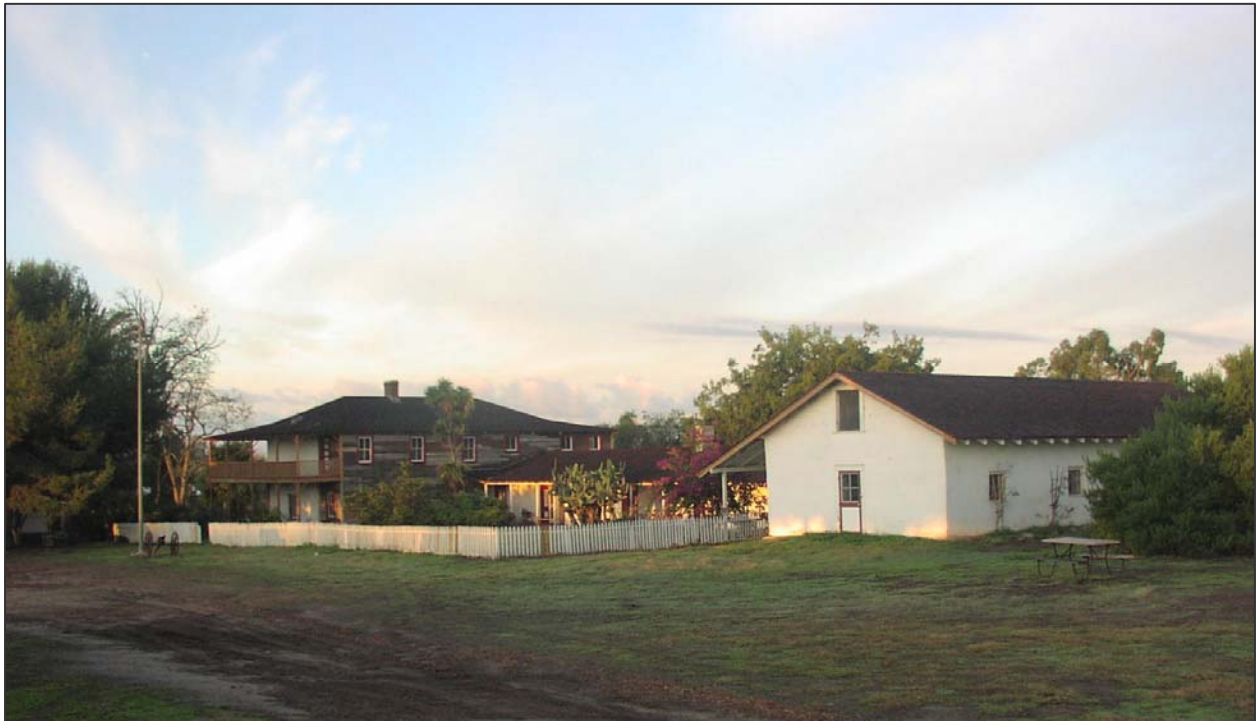
**Figure 6**

By the close of the 2004 construction season, structural and seismic stabilization of the buildings was complete, porches on the Monterey block were reinstated, building envelopes were secured against weather, and interior rehabilitation was started.
