Evolving methodology in seismic retrofit: stabilizing the Las Flores Adobe

J.M. Barrow, D. Porter, S.J. Farneth, E.L. Tolles

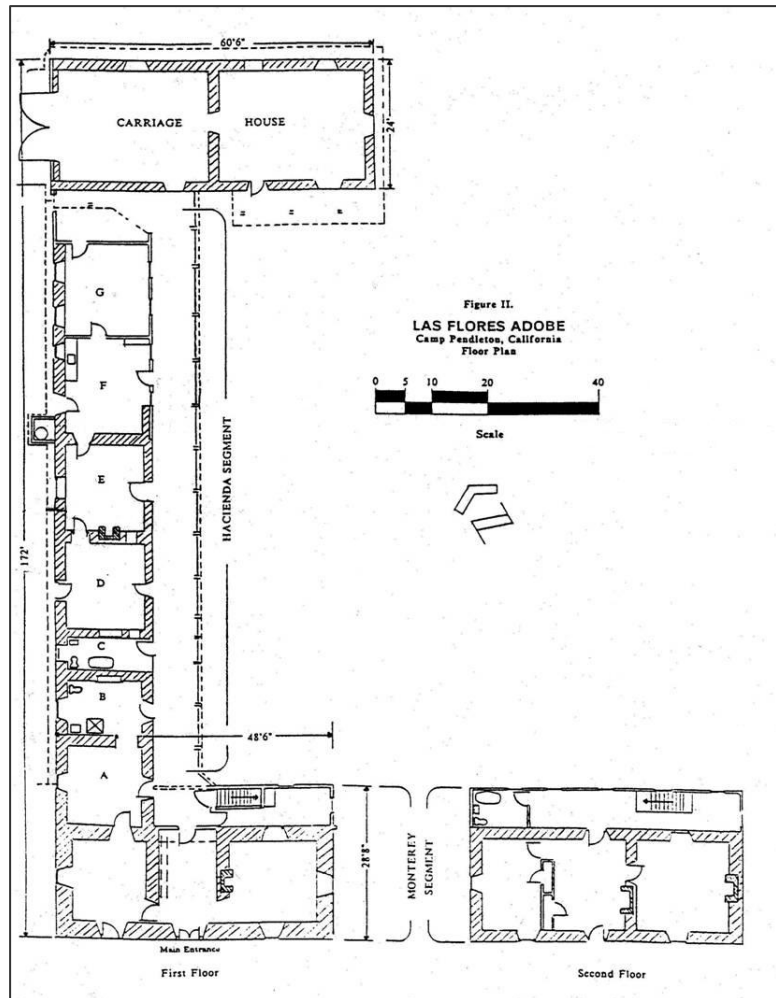
Figure 2

The buildings enclose three sides of a courtyard. Historically, fences and hedges on the east completed the enclosure.

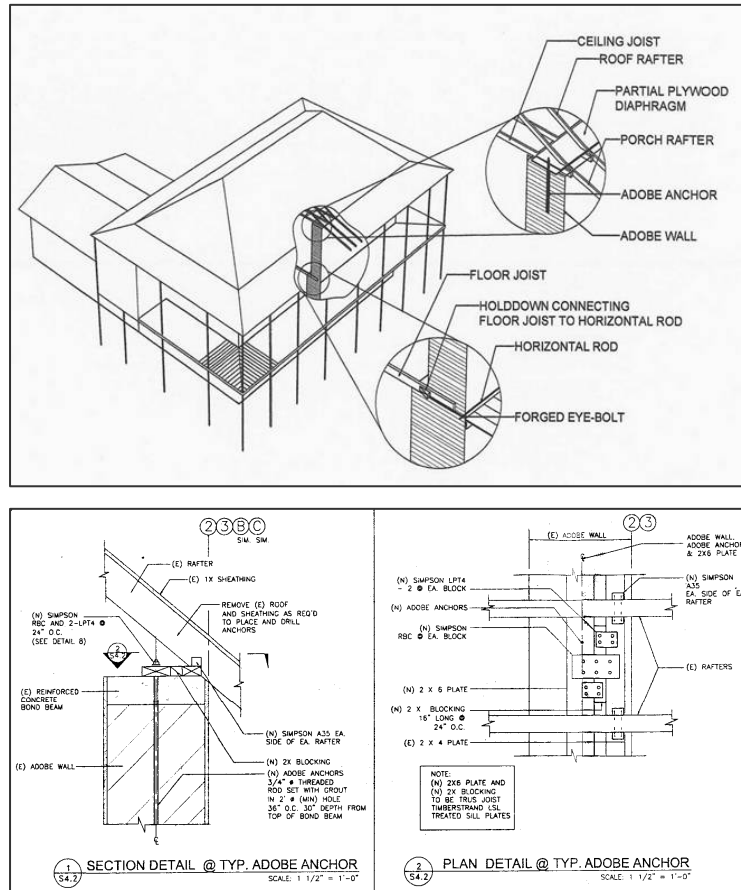
Figure 3
Retrofit design was focused on providing lateral restraint at the tops of walls and at the level of the second-floor frame in the Monterey block.

During the 2002 and 2003 seasons, the work was focused on the house. The seismic retrofit consisted of the addition of a wooden bond beam to the tops of the adobe walls, installation of center core pins, attachment of the roof frames to the tops of walls, and installation of a steel band around the exterior of the Monterey block at the level of the second-floor frame.

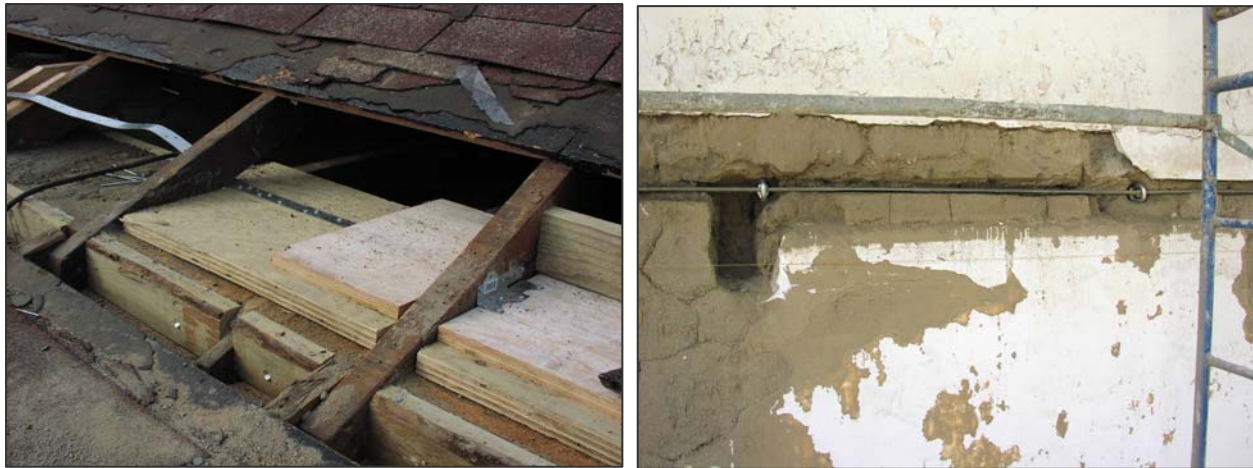
Figure 4

The tops of the walls were leveled by adding a pise course. The wooden bond beam incorporated a stainless steel strap and was fastened to the walls using center core pins and to the roof frame using commercially-available metal clips (left). At the level of the second-floor frame of the Monterey block, a stainless steel belt was installed below exterior plaster and tied back to floor joists using eyebolts and Simpson anchor brackets (right).

Where the tops of the adobe walls were uneven and out-of-level, the walls were capped with soil cement applied in pise technique. The plywood bond beam functions as a partial diaphragm and consists of two overlapping layers of pressure treated material glued and nailed to provide longitudinal strength. Once the bond beam was placed, holes 2.5 cm in diameter were drilled down through the plywood and adobe wall center to a design depth of 80+ cm to receive the threaded rod. Center core pins were set into the adobe with an epoxy grout. The epoxy selected

The steel belt installed at the second floor level attaches the floor system to the perimeter walls. A 1.5 cm channel was cut through the existing lime plaster and adobe on the walls just above the level of the second floor porch deck. Simpson HD 5A brackets were fastened to every other interior joist behind the interior surface of the wall. A threaded eyebolt was fastened into the Simpson tie with the eye set in the channel on the exterior. A 1.27 cm threaded rod was inserted into the eye, which wrapped around the entire house and fastened at the four corners to an “L” flange. On the east and west end walls in line with parallel running joists, stabilization required longer rod connectors drilled through two perpendicular joists, bolted with nuts and washers, and extending through the adobe wall to tie to the belting rod. This type of belted anchorage will contribute ductility to the walls. The anchoring capacity no longer depends on the strength of the adobe; rather it serves to restrain the adobe wall. It is highly unlikely that the rod could be pulled through the wall, and only localized crushing of the adobe is anticipated in a seismic event.

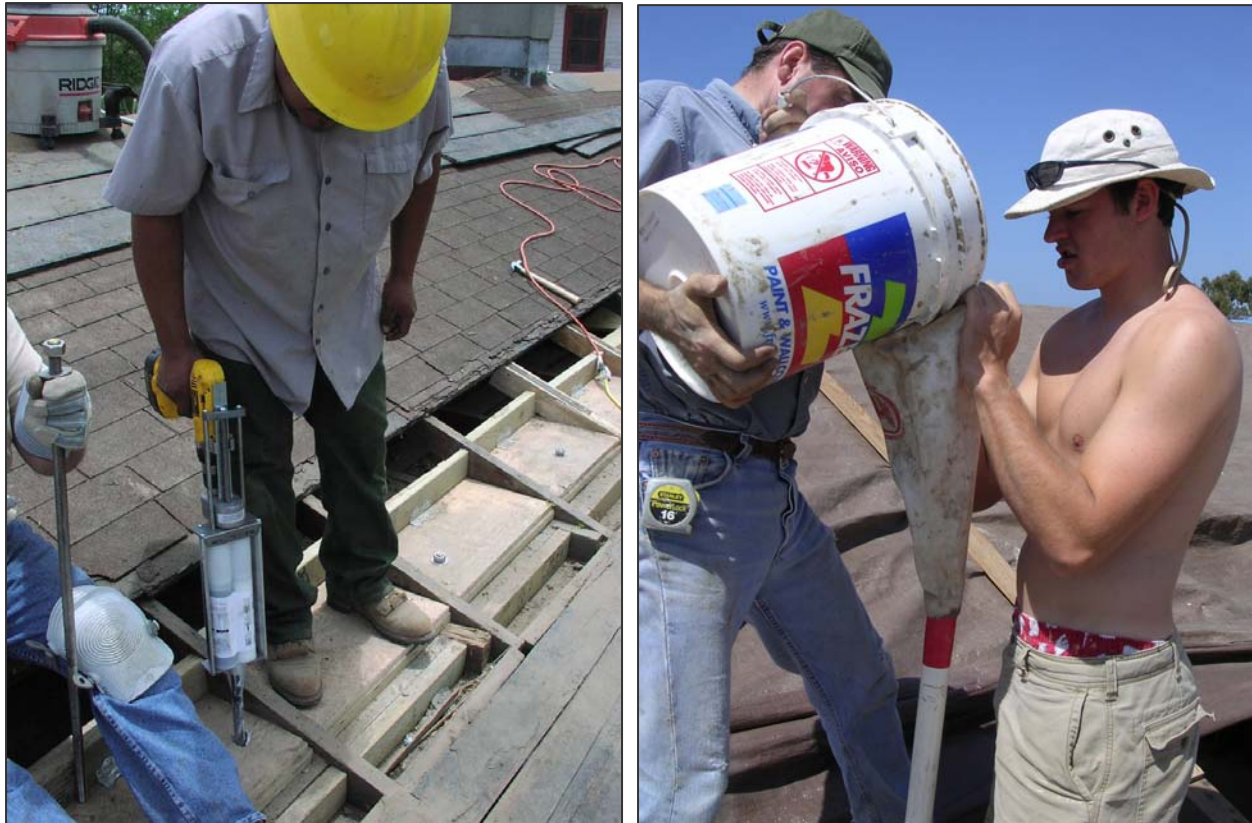
Figure 5

The crew used a resin-based grout for installing center core pins in the ranch house retrofit (left). For the carriage house retrofit, techniques were developed for installing an earthen grout (right). The earthen grout is more compatible with the historic wall materials and provides greater possibilities for reversibility of the treatment.

Rods were fixed in place using a soil-cement grout. This marked a major change in design, and represents a desire for greater compatibility and reversibility of treatments. The main house retrofit system relied on a resin-based grout with strength characteristics in excess of design criteria. Earthen grouts are compatible with historic adobe materials and offer greater potential for reversibility and thus were chosen for the carriage house. The grout mix selected was similar to one developed and tested for use in the repair of the historic Pio Pico Adobe in Whittier, California, and consisted of adobe soil, sand, a small amount of Portland cement, and a grout additive (SikaFlex II) to minimize shrinking during curing.

Low-tech methods were developed for placing the grout. An adobe test wall was constructed and placement methods were developed and practiced until placement could be effected smoothly, yielding a consistent result. A placement device was made by attaching a grout bag to a length of plastic pipe. The pipe allowed placement to begin at the bottom of the holes, preventing voids due to trapped air bubbles. The method for placement involved filling the device with grout and twisting off the bag to prevent loss of material when transferring the grout to the hole to be filled.

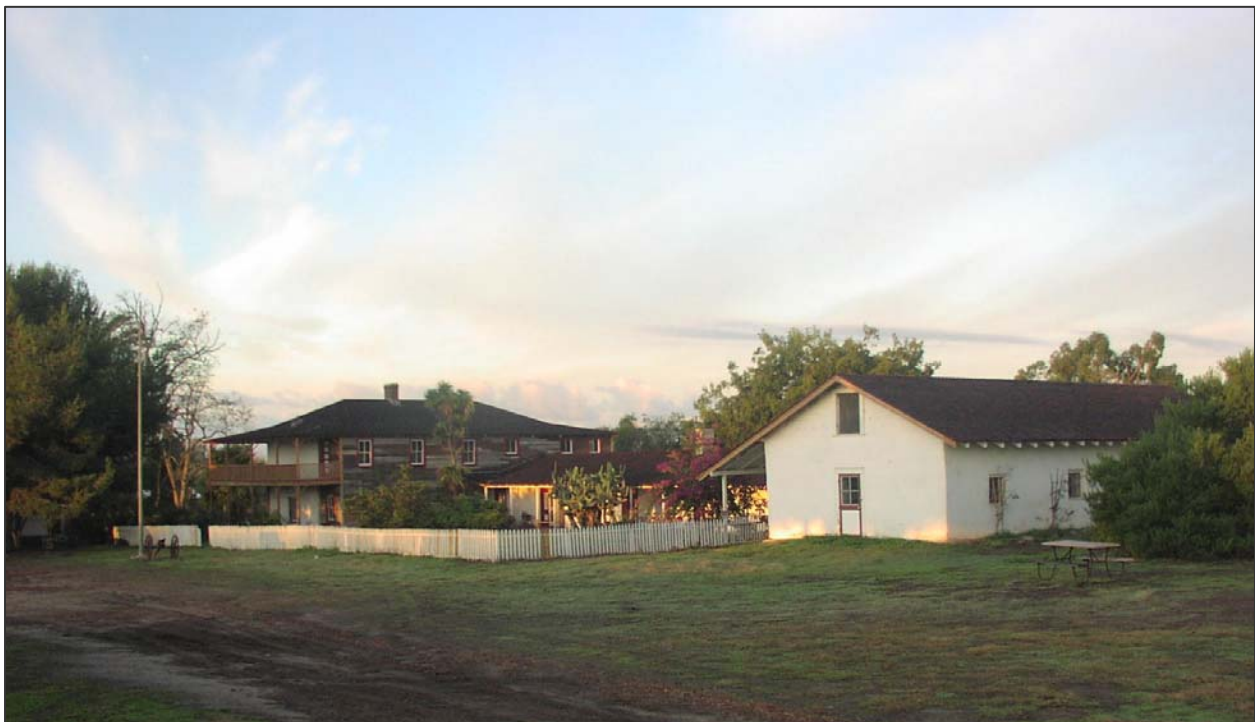
Figure 6

By the close of the 2004 construction season, structural and seismic stabilization of the buildings was complete, porches on the Monterey block were reinstated, building envelopes were secured against weather, and interior rehabilitation was started.
