## **Assessment and Analysis of the Breeding Barn at Shelburne Farms**

David C. Fischetti<sup>1</sup>, Douglas W. Porter<sup>2</sup>, Ronald W. Anthony<sup>3</sup>

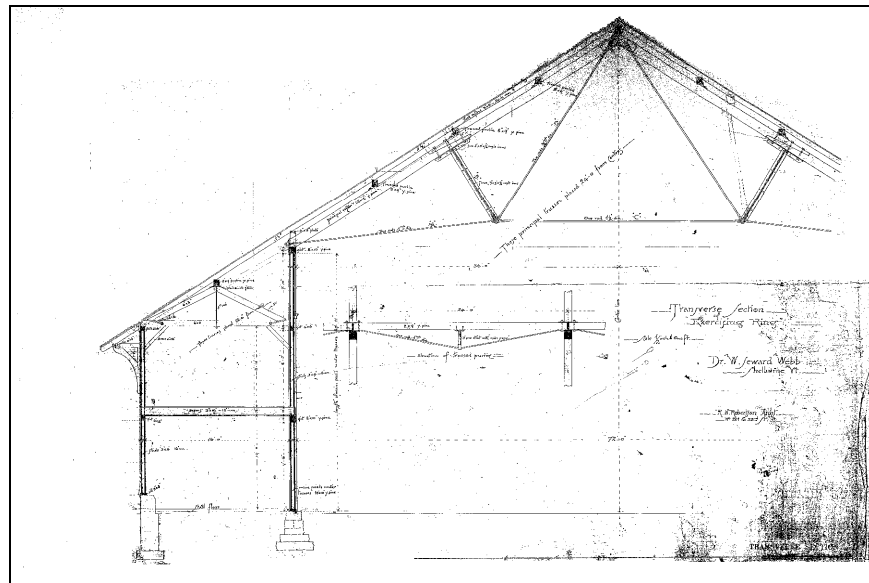
**Figure 3.** Robertson's earliest drawings of the roof frame omitted the iron cross-tie braces at plate level.

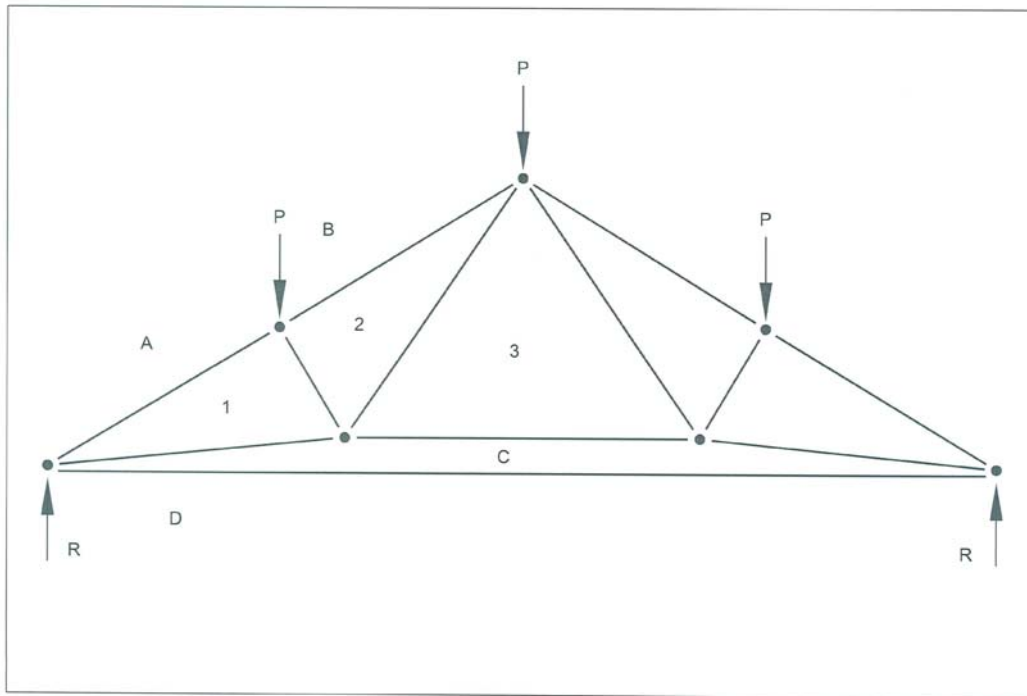
1. The truss members are connected together with frictionless pins.
2. Truss members are straight and the axis of the members intersect at joints.
3. Deformations under load do not excessively change the basic truss geometry.
4. Loads and reactions are applied only at joints (Figure 9).

**Figure 9.** This shows the placement of the unit loads for the load test with the loads located at joints.

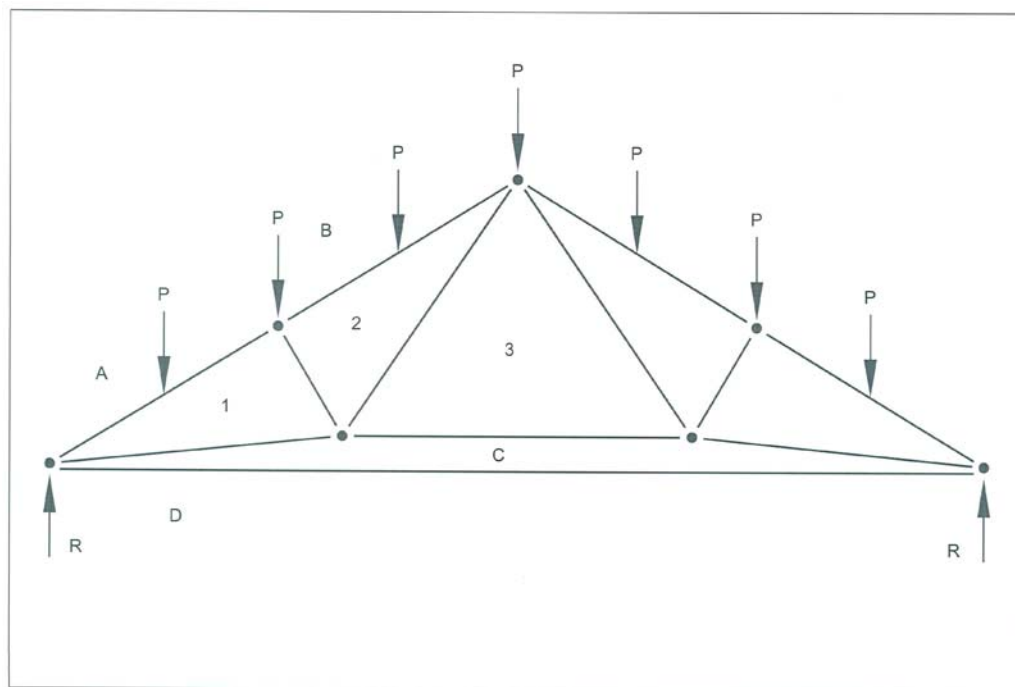
Apparently, the truss in the riding ring evolved from a simple truss analyzed by graphical means, to one with purlins located between joints (Figure 10), to a system combining a truss with a horizontal tie (Figure 11). The wrought iron angles used to bolster the spliced top chord is an interesting detail. These may have been added as an afterthought, sometime during design, to reinforce the top chord acting as a two-span beam supporting purlins at the midpoint of both spans. Although it certainly was possible to obtain southern pine in twelve-meter lengths to produce a two-span continuous top chord, the designers chose to

**Figure 10.** This shows the placement of the unit loads for the load test with the loads located at purlins.
