# Carriage house stabilization at the Las Flores Adobe site: field school training in the conservation of historic adobe structures

J.M. Barrow

D.W. Porter

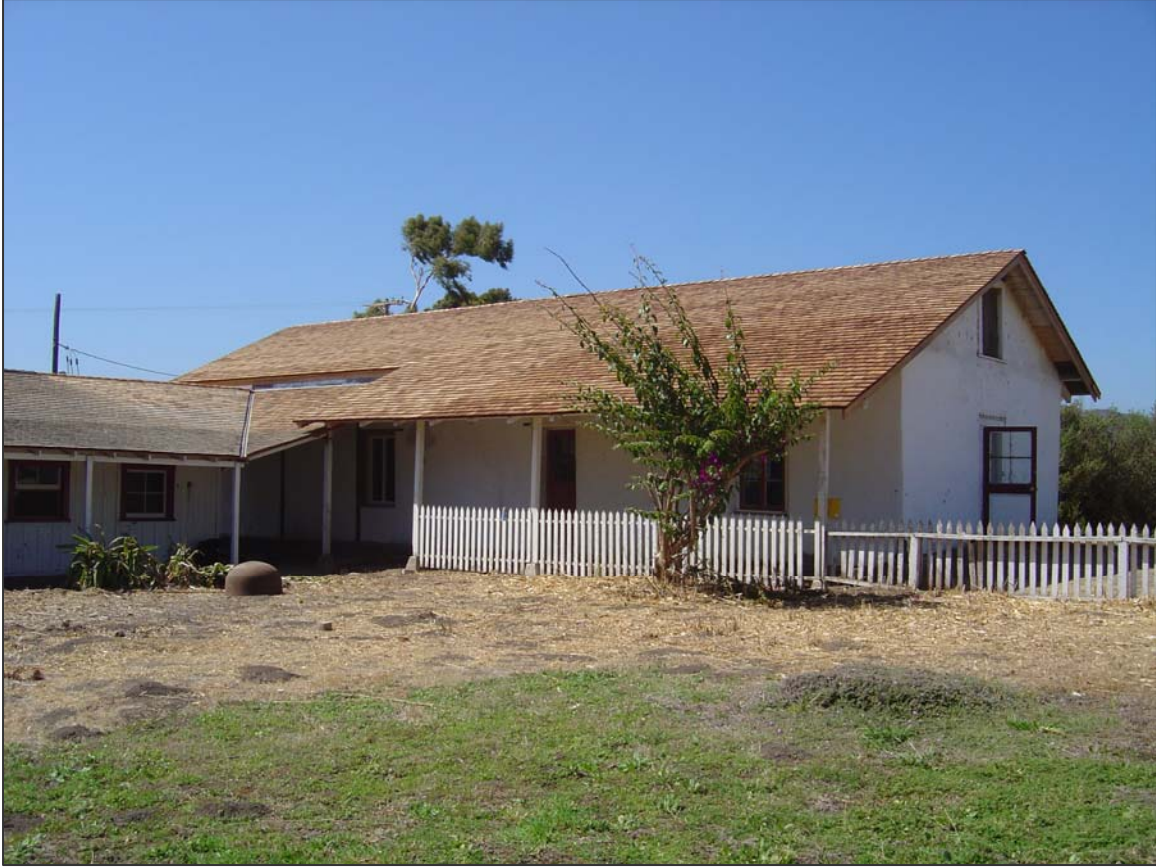
During the course of this project, new technologies were implemented, graduate students and staff received training in traditional crafts and conservation skills, and an important resource was conserved.
